## Global Security Verification Report

### Facility Name: Allplast Bangladesh Ltd

| Date of Verification: | 09-Mar-2025 | Report Number: | A5219320 |

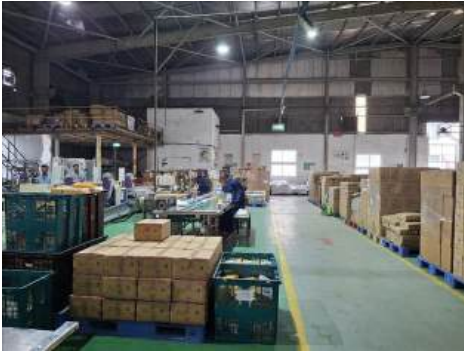
## Packing Area

| ID # | Finding | Rating |
|---|---|---|
| <b>Auditor Comments</b><br>Based on the facility visit, review of CCTV monitoring records, and management interviews, it was found that CCTV is used, and recordings are maintained for areas such as the main gate, perimeter/fence, finished goods storage and packing area. However, the camera placements do not provide adequate coverage of activities in the finished goods storage area on the ground floor and all two packing areas located on the ground and 1st floors of Building 1. | | |

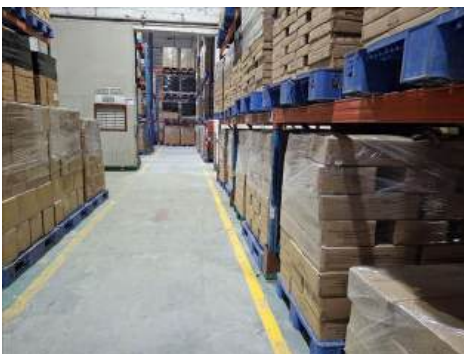
## Finished Goods Warehouse

The facility has 28 CCTV cameras in different locations of the facility and recordings are maintained for areas such as the main gate, perimeter/fence and packing sections. However, the finished goods storage area is not covered. Additionally, the camera placements do not provide adequate coverage of activities in all two packing areas located on the Ground floor and 1st floor of Building 1.
